BIOGAS PLANTS AT SINZA HOSPITAL; DAR ES SALAAM

Final Report

Christopher Kellner (Dipl. - Ing.)
Consultant on Biogas and Sanitation
kellnerbiogas@yahoo.com
+255784862495

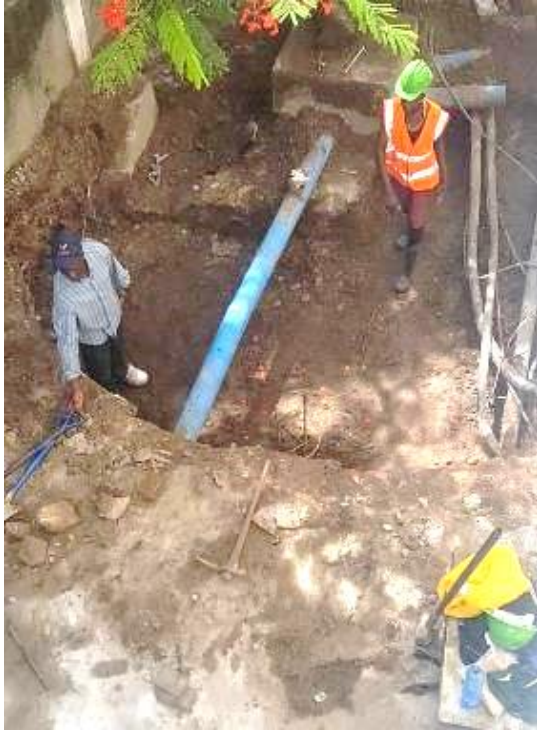
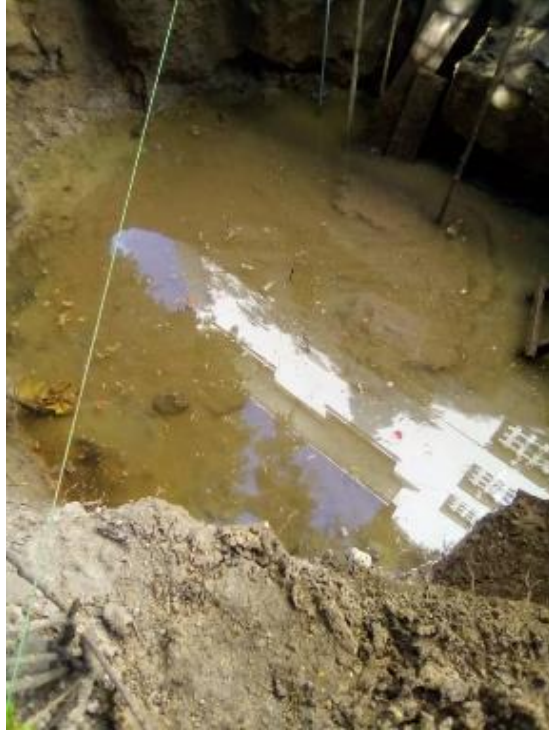
The old underground structures and the underground water were not unexpected, but quite some challenges for the construction workers.

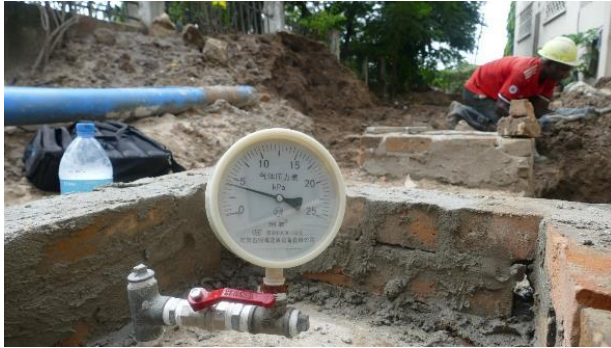
The pressure test was well conducted and proved good quality of the workmanship applied. Both digesters are gastight and watertight. The pressure indicator was holding the pressure constantly over 4 hours.

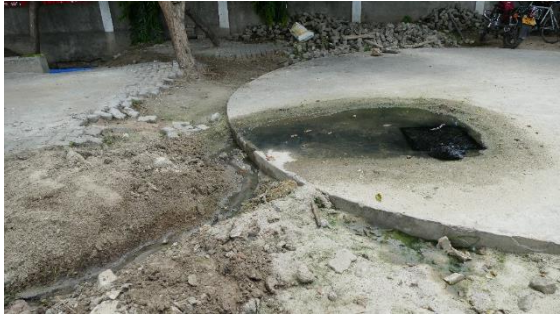
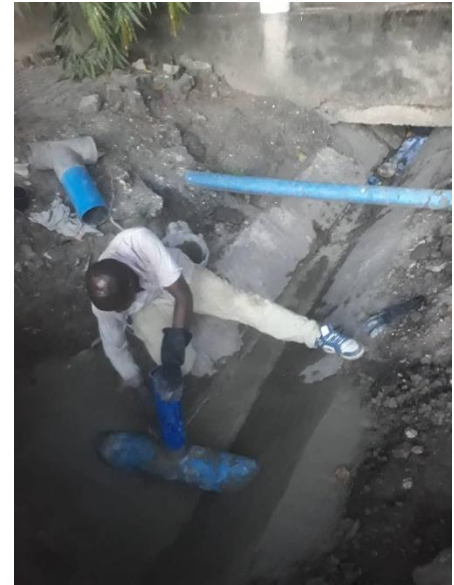
Before and after. At the onset of the project wastewater was overflowing from the soak-away pit. In order to keep the precise maximum level in the sewage piping system to avoid clogging of pipes, an overflow pipe was installed and precisely levelled. When water levels reach the top of the pipe a vacuum tanker must empty the soak-away pit.

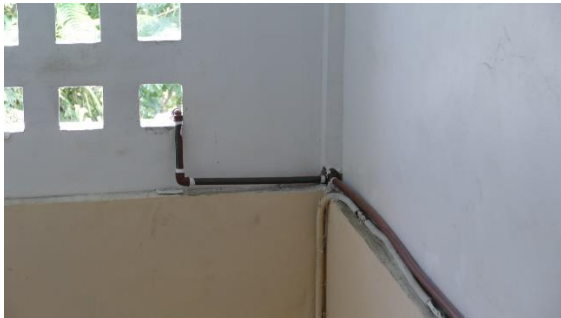
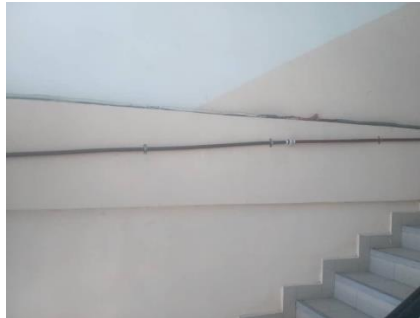
If a biogas piping system is laid up and down, condensation water can clog it. The pipe had to be re-done with a constant slope towards the digester so that condensation water flows back in the digester.

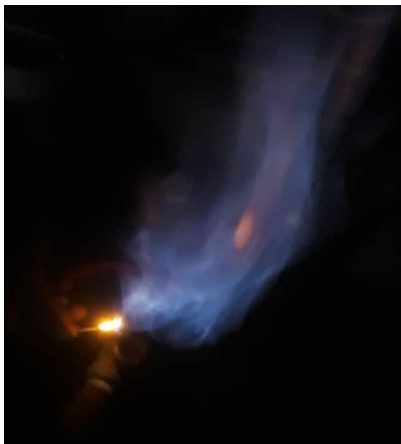
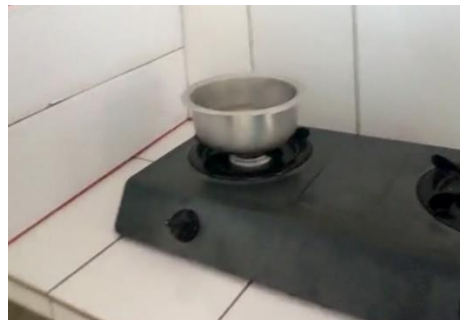
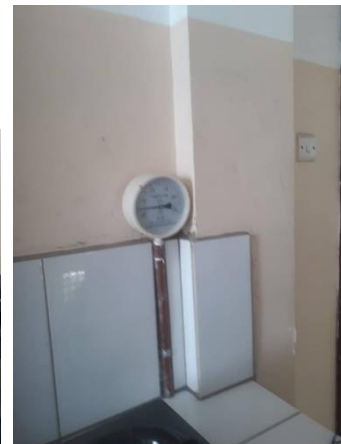
The gas produced by placentas and other organic waste started burning on the 21st of February 2020. The fixed installed pressure indicator will provide an overview on how much gas is available in the digesters.
